# 17-year-old Warehouse Worker Crushed by Forklift

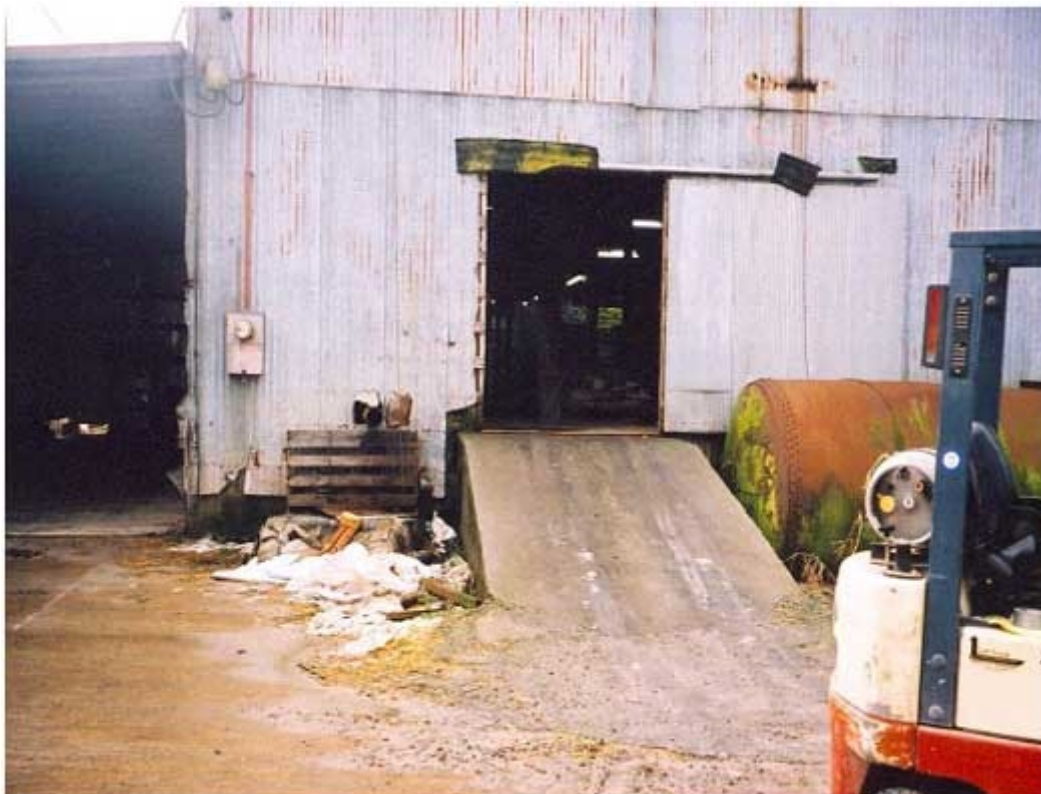
## Photo 1

The incident happened at an agricultural cooperative (co-op). The co-op's retail store was connected to the co-op's tire shop and a warehouse. Also, on the grounds was an equipment storage shed, a fertilizer shed, and an outdoor storage area where 200-pound molasses animal licks were stored. A large flat concrete parking lot extended in front of the store entrance and around one side of the warehouse where a loading dock and ramp were located – Photo 1.

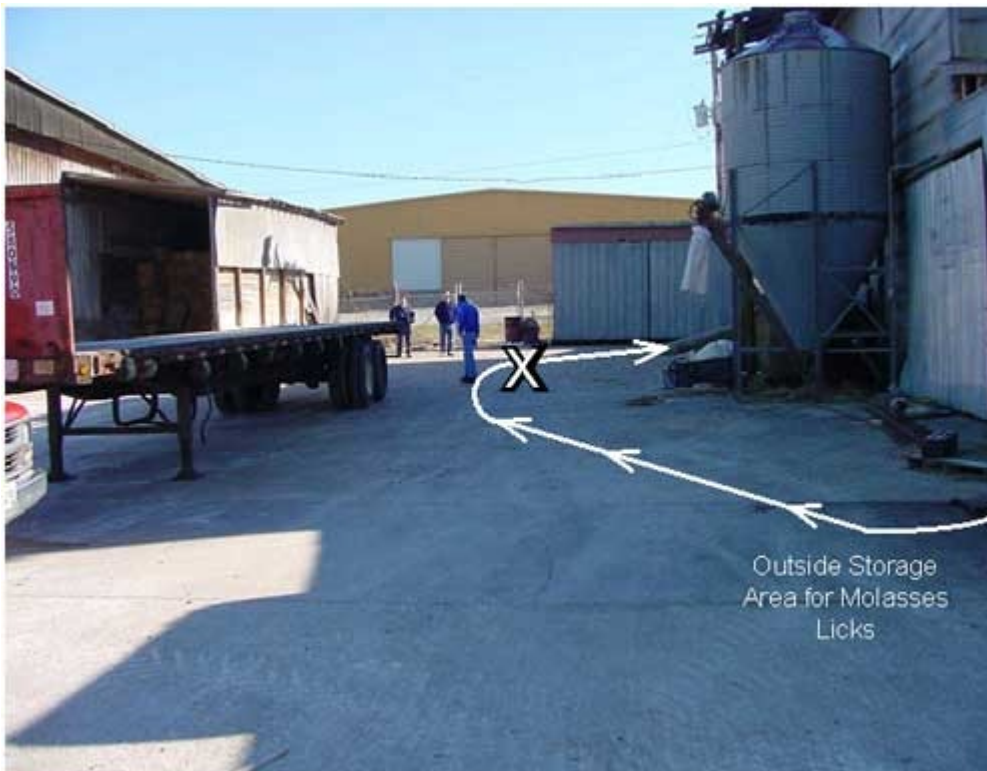
## Photo 2

It appeared the victim was traveling toward the warehouse ramp on the level surface of the parking lot and made a sharp right turn to enter the narrow ramp leading up to the warehouse. It is surmised this is when the forklift tipped over onto its left side. The forklift was not loaded but its forks were raised approximately 20 inches. There was a single 12-foot skid mark located on the parking lot where it is surmised the victim started into a right turn toward the ramp.

Photo 2 illustrates the parking lot, warehouse and ramp, and other co-op buildings. Lines on the photo approximate the travel path of the forklift on the day of the incident. An "X" marks the approximate location of the forklift that had tipped over. Photograph courtesy of the Tennessee Department of Labor and Workforce Development, Division of Occupational Safety and Health.
